ELANCO ENTERPRISES LTD.

**Hydrogeological Assessment of Potential Impact of Proposed
Rainbow Ridge Affordable Rental Housing Project,
965 Beasley Road, Cortes Island, B.C.**

**PREPARED FOR
CORTES ISLAND SENIORS SOCIETY.
MANSON'S LANDING, CORTES ISLAND, B.C.**

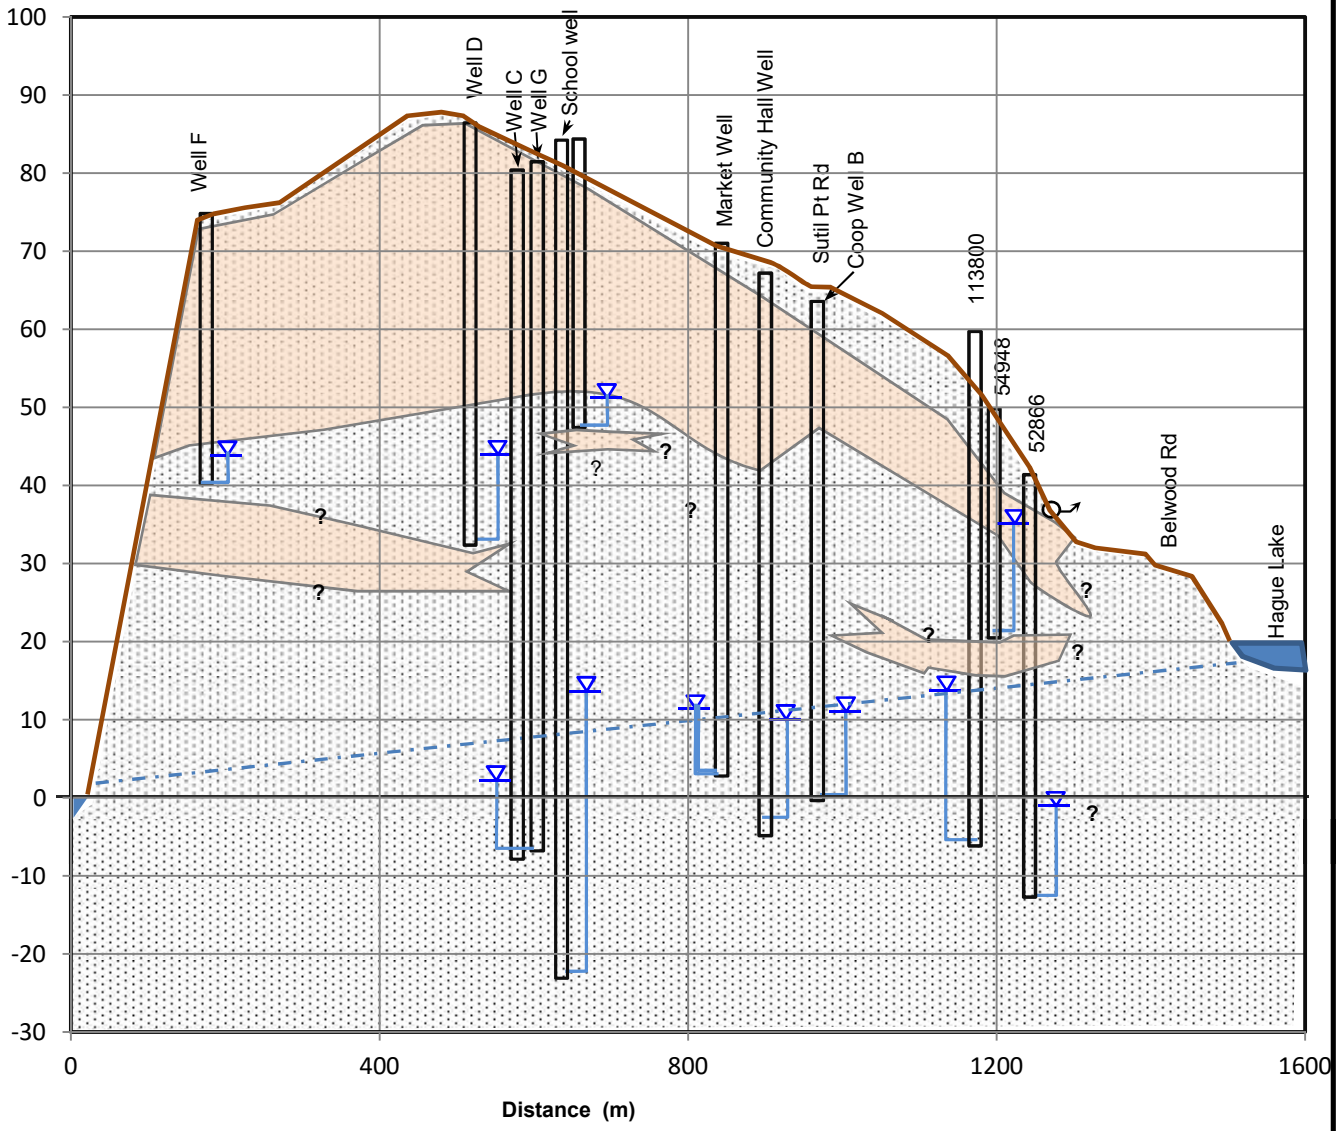
See legend on Fig. 4

○ ↗ Developed spring

The driller's log of the Senior's Village well (Well G) indicated that the hole penetrated a silty sand and gravel layer to a depth of 23m, starting at ground surface (see Profile on Figs. 4 and 6). This is the same unit where many dug wells have their water source, suggesting that there are some horizontally permeable zones within the upper part of this unit.

A review of the profiles indicated in the hydrogeological sections on Figs. 4 and 6, suggested that a 80m deep well drilled on the Senior's Village property (951 Beasley Road) had the potential for adequately penetrating the deep aquifer to provide a yield (40 to 70 L/min) similar to other wells in the area. While a shallow perched aquifer is present in areas west of the Village the drilling results confirmed that it did extend below this property.

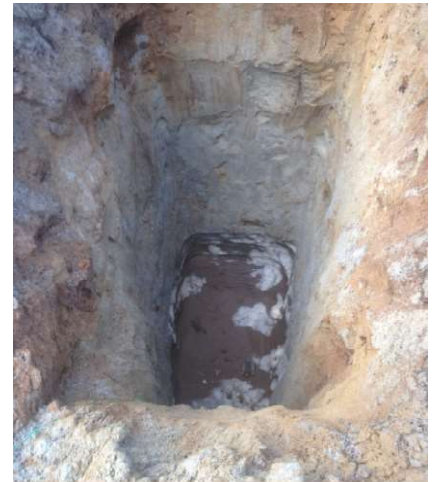
Concept for Deep Infiltration Pit

Profile

Plan

Test Pit in Quadra Sand at Qualicum Beach

- 1) Dimensions are for illustrative purposes only . Actual dimensions will vary.
- 2) Water storage capacity for this example is about 2.6 m³.
- 3) Potential infiltration capacity could range up to 13m³/day in Quadra Sand unit.
- 4) These deep pits can only be effective in areas where Quadra Sand can easily be accessed at a depth reached with a backhoe.
- 5) Locations near the north-south ditch could be very beneficial in diverting a portion of the flow.

- Consideration should be given to digging a series of deep pits to explore the possibility of constructing deep infiltration pits in selected locations.

- 1) A simplified version of this basin could be constructed along side the north-south ditch.
- 2) A deep seepage infiltration pit (see Fig. 8) could be used to help drain the pond following an intense runoff event.
