## WELLHEAD PROTECTION PLAN FOR SENIORS VILLAGE WELL

951 BEASLEY ROAD, CORTES ISLAND

- Table I Capture Zone Analysis and Travel Time  
Table II Assessment of Potential Risk of Well Contamination  
Figure 1 Location Map - Showing Extent of Well Capture Zone.  
Figure 2 Hydrogeological Section A - A'  
Figure 3 Log of Seniors Village Well

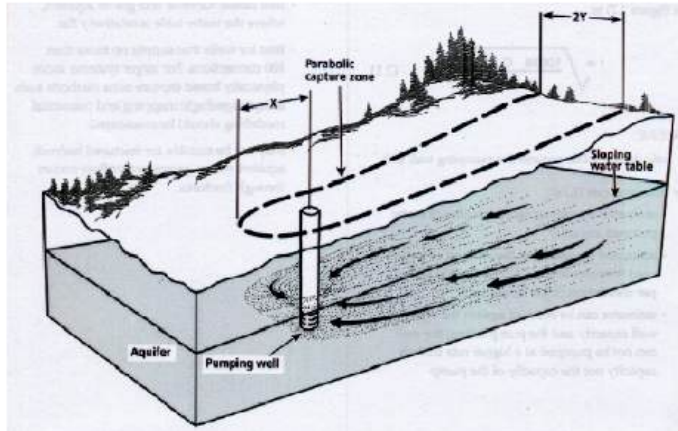
- 1) Assumes a constant pumping rate based on the conservative water consumption value indicated above.
- 2) Transmissivity calculated from 4 hour pump test drawdown data
- 3) Average gradient between local area wells.
- 4) See dimension illustration below

Formula	Symbol	Parameter	Note No	Value	Unit
		Village housing units		10	
		Estimated water usage		1.25	m <sup>3</sup> /d
$Y = Q/2T/i$	Q	Pumping rate	1	12.50	m <sup>3</sup> /d
				0.00014	m <sup>3</sup> /s
				0.145	L/s
				2.3	gpm
				3,313	gpd
T	Transmissivity	2	6.6E-04	m <sup>2</sup> /s	
			57.0	m <sup>2</sup> /d	
i	Gradient	3	0.017		
$X = Y/pi$	Y	half width	4	6.5	m
	2Y	Width		13.0	m
	x	down distance	4	2.1	m

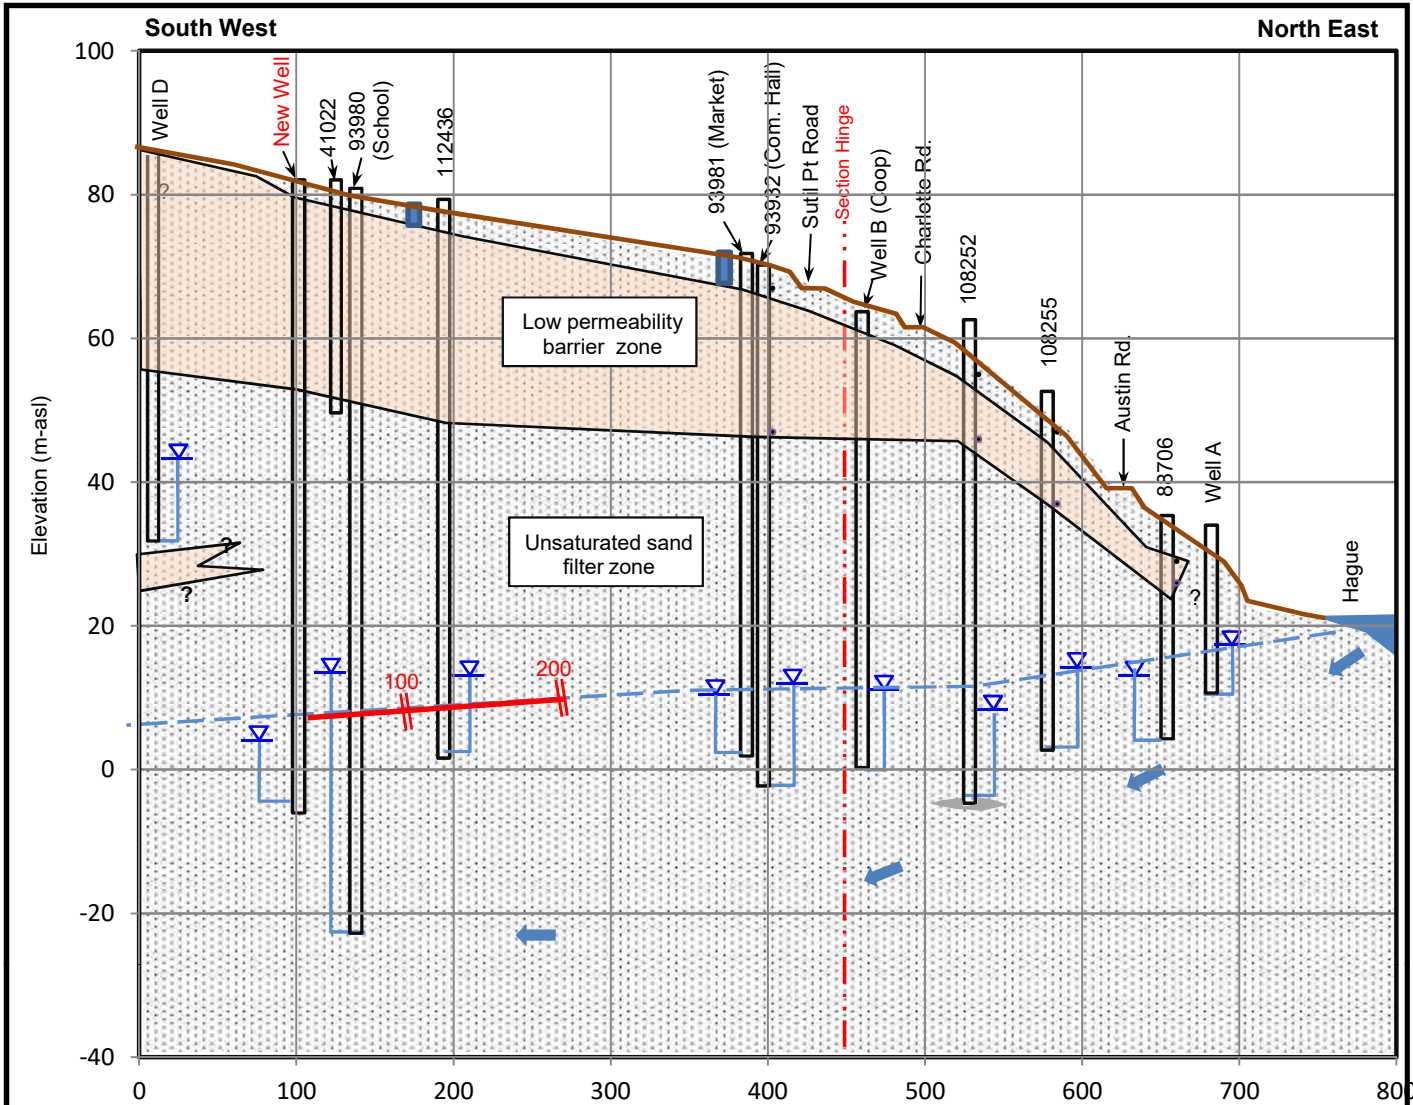
**Legend**

- Clay layer
- Dug well (See Note 3)
- Fine sand, with some gravel and occasional silt lenses.
- Interpreted hydraulically restrictive layer (See Note 2)
- Drilled 150mm diameter steel cased water well. The number is the Provincially assigned Well Tag number.
- Elevation of static water level at time of well construction.
- Well screen location.
- Interpreted groundwater flow direction
- 100 day flow distance to New Well

**Vertical exaggaration = 10x**

- 1) See location of section on Fig. 1
- 3) The restrictive layer is a zone with higher apparent silt content in the sand and is generally grey in colour. It is not well defined in many areas.
- 3) Dug wells are typically 5 to 7m deep and are rarely used for a potable water supply in the area..

Topic	Elements	Comments
a) Location, topography and drainage	Site plan	Fig. 1 attached
	Hydrogeological profile	Fig. 2 attached
	Topographic contours	Reviewed and presented in another report
	Well locations	Yes
	Drainage flow directions	Reviewed and presented in another report
	Conditions around well head	Well drained
	Potential sources of contamination	On-site wastewater systems and fuel tanks

e) Hydrogeological conditions and aquifer characteristics	Origin and nature of aquifer and confining zones	Unconfined Quadra medium to fine sand aquifer with overlying unsaturated sand (>10m thick) and a restrictive silty sand layer (>6m thick).
	Non pumping water levels	Indicated on Fig. 2
	Pump test data	Assessed and key results presented in another report
	Aquifer recharge	Principal source of aquifer recharge is infiltration from Hague Lake

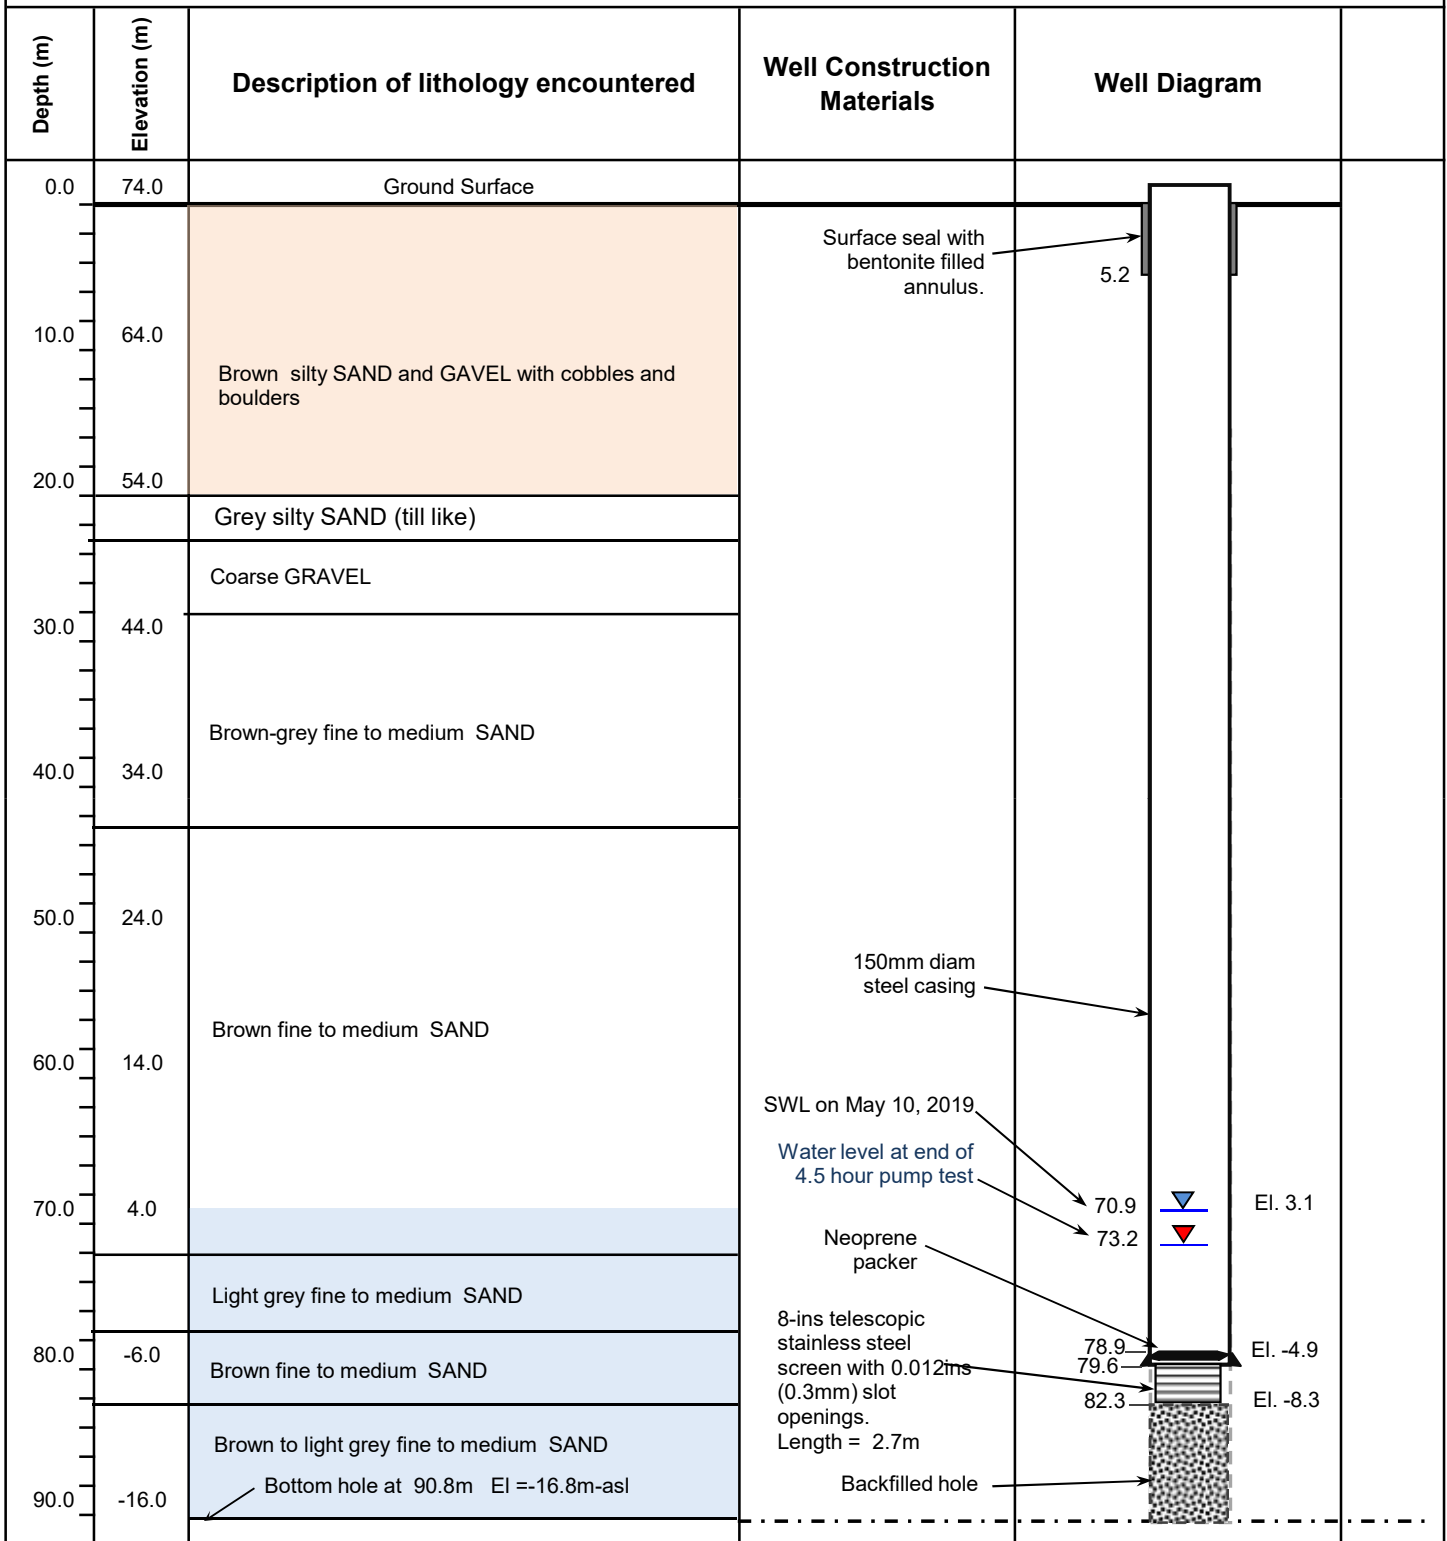
<b>Borehole No: Seniors Village Well</b> Date Drilled: April 2019 Method: Air rotary Datum above ground (m): ..... 0.57 Elevation top of flange (m-asl): ..... 74.6	Constructed By: Red Williams Well Drilling Ltd. Hole Diameter: 150 mm Ground elevation: 74.00 m-asl Depth to water at construction : 70.1 m-below top of casing Depth to water below ground: 69.5 m-bg
---	--

d) Well and well head conditions	Detailed well log	See attached Fig. 3
	Depth to water intake	The depth to the top of the well screen is 79.6m below ground, which easily exceeds the GARP trigger guideline depth of 15m
	Well yield and efficiency	Assessed and presented in another report
	Distances from surface water bodies	Distance to Hague Lake = 510m
	Depth to water bearing zones	Presented on Figs. 2 and 3
	Pump installation details	To be determined by others
	Well head completion details	To be determined by others, however top of casing is to be flood proof and surface drainage directed away from the wellhead, as per the BC Groundwater Protection regulation.
